DEPARTMENT OF TRANSPORTATION

Contract #: 04-0120F4Cty: SF/ALA Rte: 80 PM: 13.2/13.9File #: 69.28**WELDING INSPECTION REPORT****Resident Engineer:**Pursell, Gary**Address:** 333 Burma Road**City:** Oakland, CA 94607**Report No:** WIR-012520**Date Inspected:** 16-Feb-2010**Project Name:** SAS Superstructure**OSM Arrival Time:** 700**Prime Contractor:** American Bridge/Fluor Enterprises, a JV**OSM Departure Time:** 1900**Contractor:** Zhenhua Port Machinery Company, Ltd (ZPMC), Changxing Island **Location:** Shanghai, China

WELDING INSPECTION REPORT

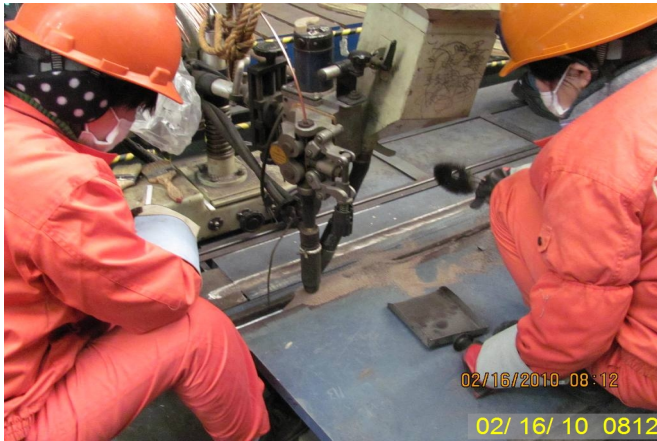
2.This QA inspector, Baskar Govindarajan, observed, ZPMC qualified welding personnel identified as 040699 perform SAW welding on, Spare strut splice plate, and weld joint identified as ED1-SA4-68-135 mtr.-6-1B. ZPMC CWI Identified as Mr. Mao Bin Bin. The welding parameters as measured using QC's calibrated instruments appeared to be in general compliance with WPS-B-T-3221-TC-U5-S-1. (Photo attached)

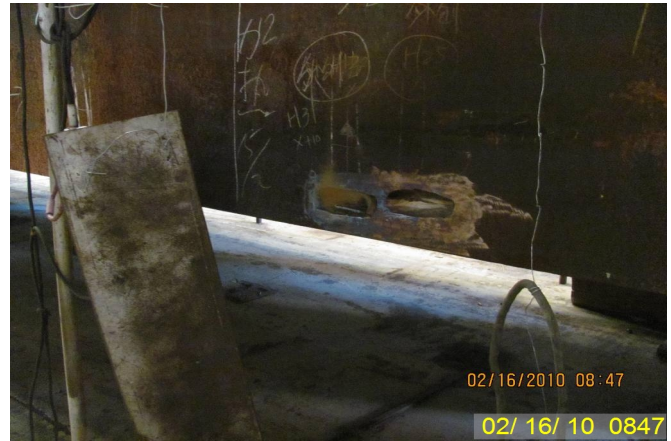
3.This QA inspector, Baskar Govindarajan, observed, ZPMC qualified welding personnel identified as 066361 perform SMAW repair welding on, BC corner of West tower, Lift 4, and weld joint identified as WSTL4-2 B/L-58A. ZPMC CWI Identified as Mr. Li lin. The welding parameters as measured using QC's calibrated instruments appeared to be in general compliance with WPS-345-SMAW-2G (2F)-Repair.(Photo attached)
